STATEMENT OF ENVIRONMENTAL EFFECTS

IN SUPPORT OF A DEVELOPMENT APPLICATION

PROPOSED COBAR MINE WORKERS VILLAGE EXPANSION
12769 BARRIER HIGHWAY, COBAR NSW

Report Title:	<i>Statement of Environmental Effects</i>
Project:	<i>In Support of a Development Application</i>
Client:	<i>Rovest Holdings Pty Ltd</i>
Report Ref.:	<i>218322_SEE_001C.docx</i>
Status:	<i>Final</i>
Issued:	<i>20 June 2019</i>

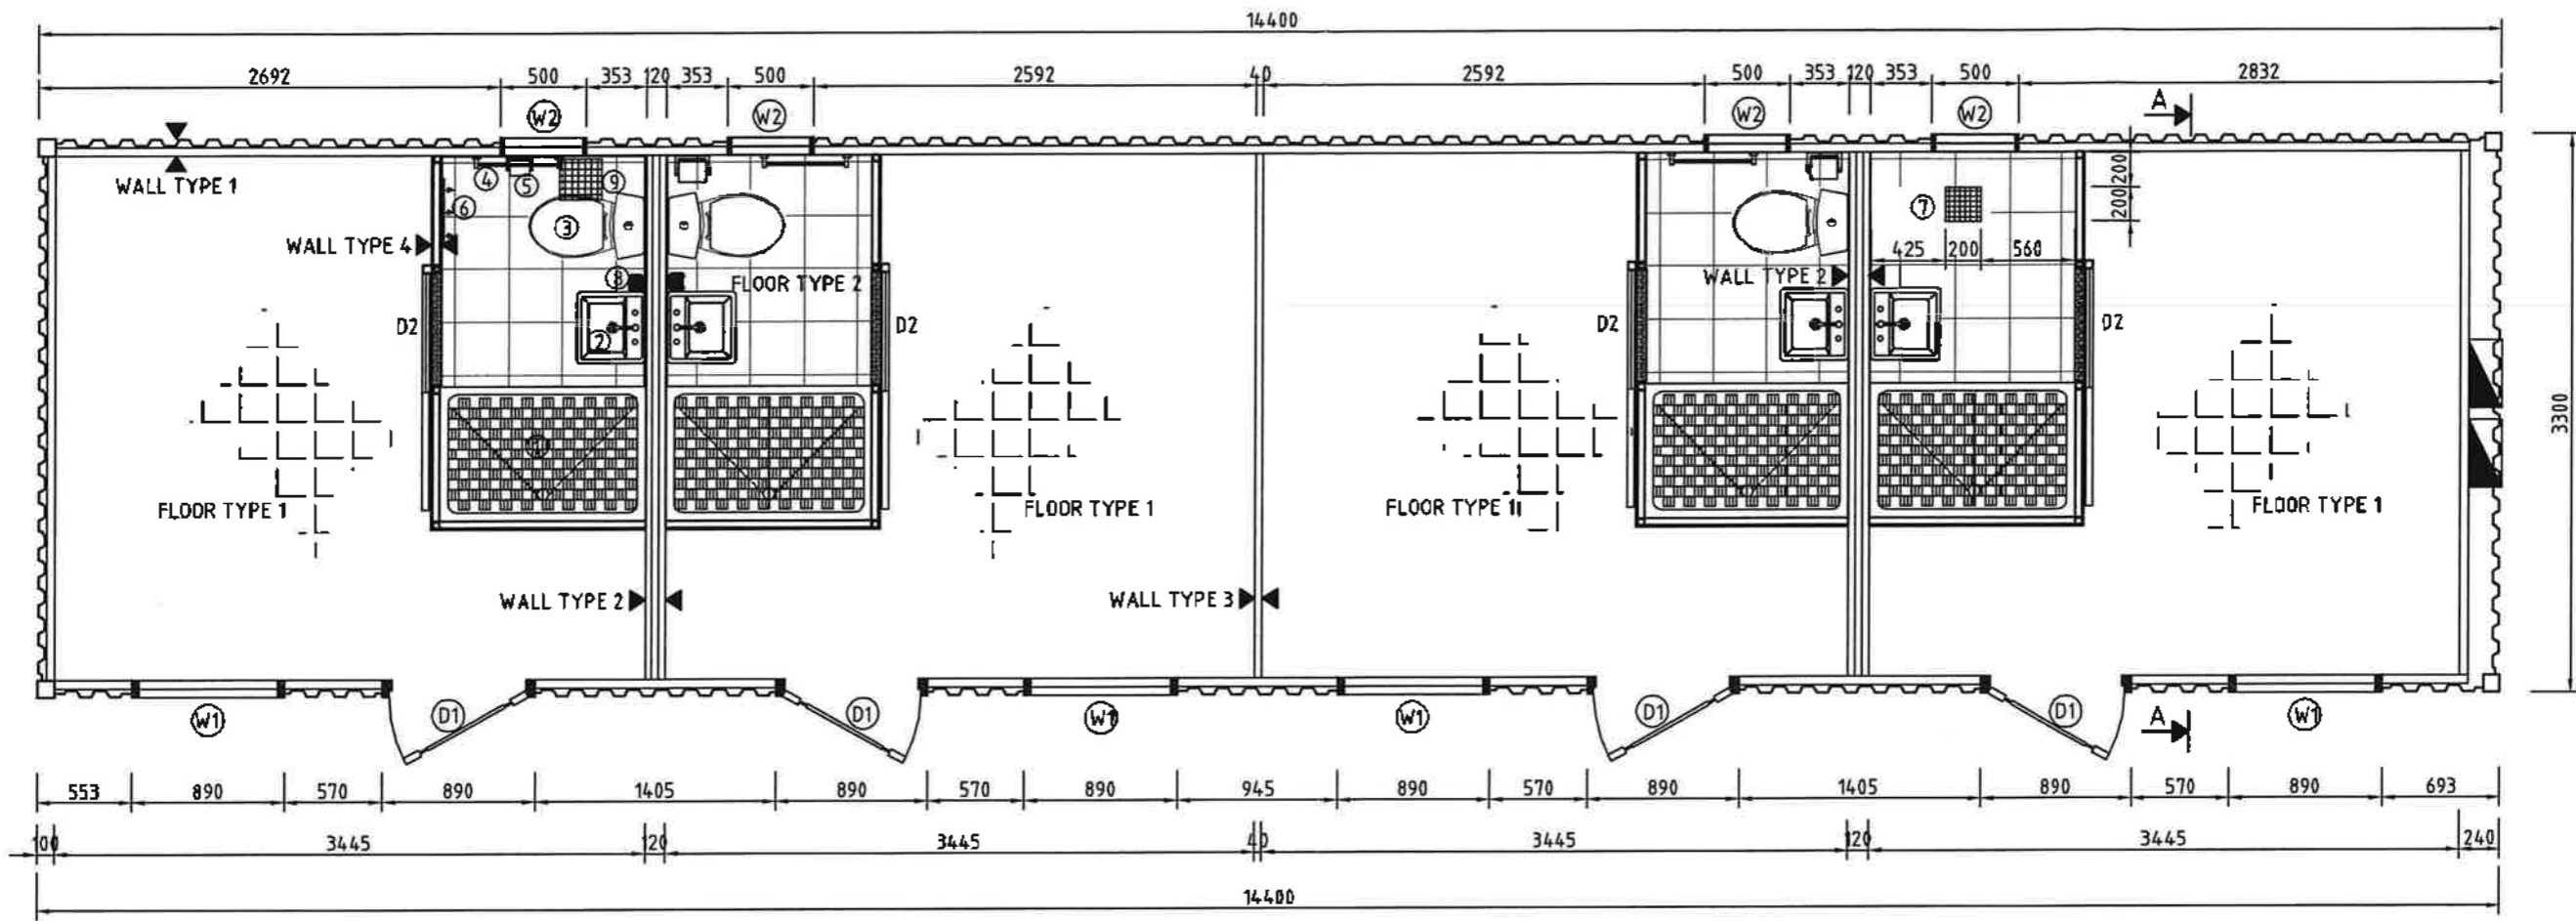
LAYOUT PLAN
SCALE 1:50

- D1. 2150 x 890 EXTERNAL STEEL DOOR
- D2. 2040 x 710 INTERNAL HIGH DENSITY FIBREBOARD SLIDING DOOR
- W1. 1050 x 890 ALUMINIUM DOUBLE TEMPERED GLAZING SLIDING WINDOW
- W2. 350 x 500 TEMPERED GLASS FIXED WINDOW
- 1. 1200x800 COMPOSITE SHOWER UNIT C/W SHOWER CURTAIN AND SOAP HOLDER
- 2. HANDBASIN CABINET C/W ACRYLIC PANEL ABOVE AND SHAVING CABINET
- 3. WATER CLOSET
- 4. TOWEL RAIL 600 LONG
- 5. PAPER HOLDER
- 6. COAT HOOK
- 7. CEILING EXHAUSTED FAN
- 8. SOAP DISH
- 9. CEILING EXHAUSTED FAN

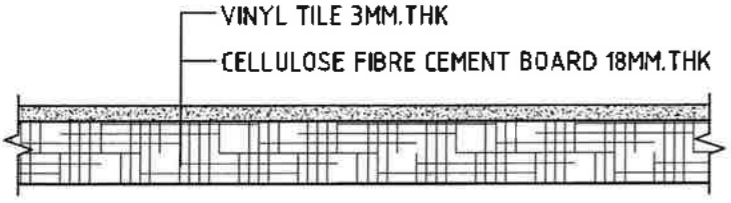
DETAIL OF FLOOR TYPE 1 (TYPICAL)
SCALE 1:5

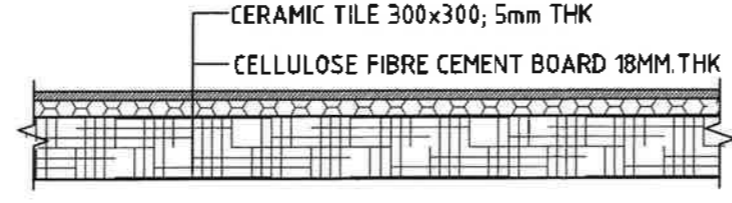
DETAIL OF FLOOR TYPE 2 (TYPICAL)
SCALE 1:5

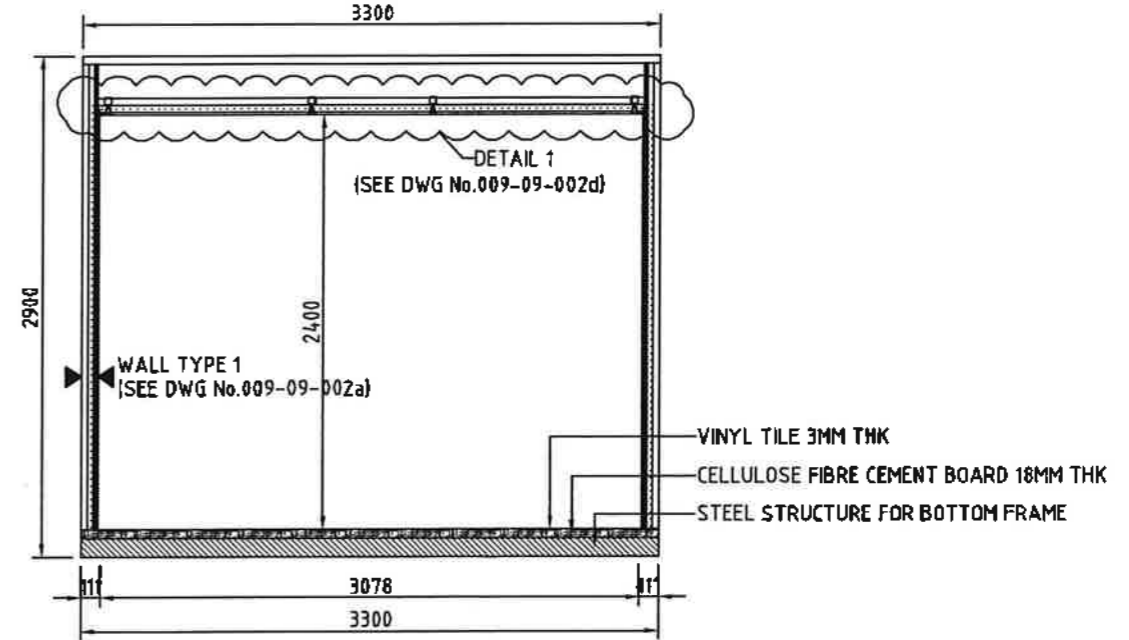
SECTION A-A
SCALE 1:50

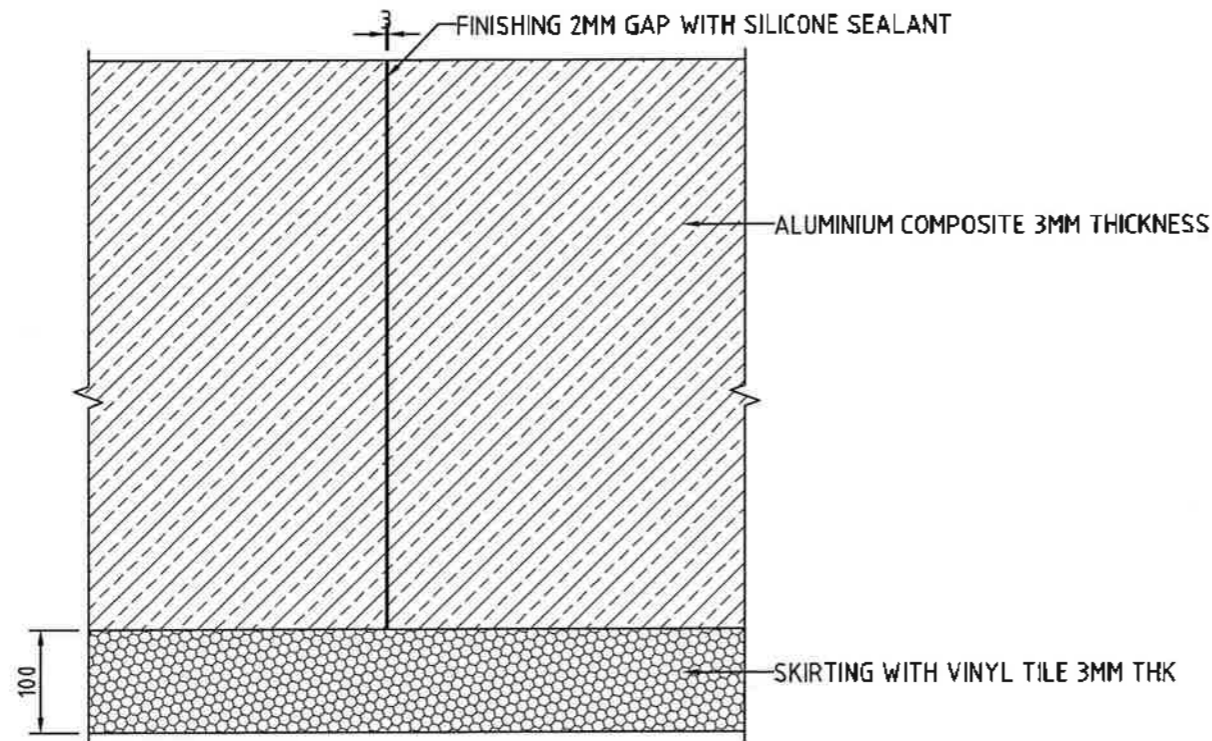
DETAIL OF WALL TYPE 1 OUTSIDE BATHROOM (TYPICAL)

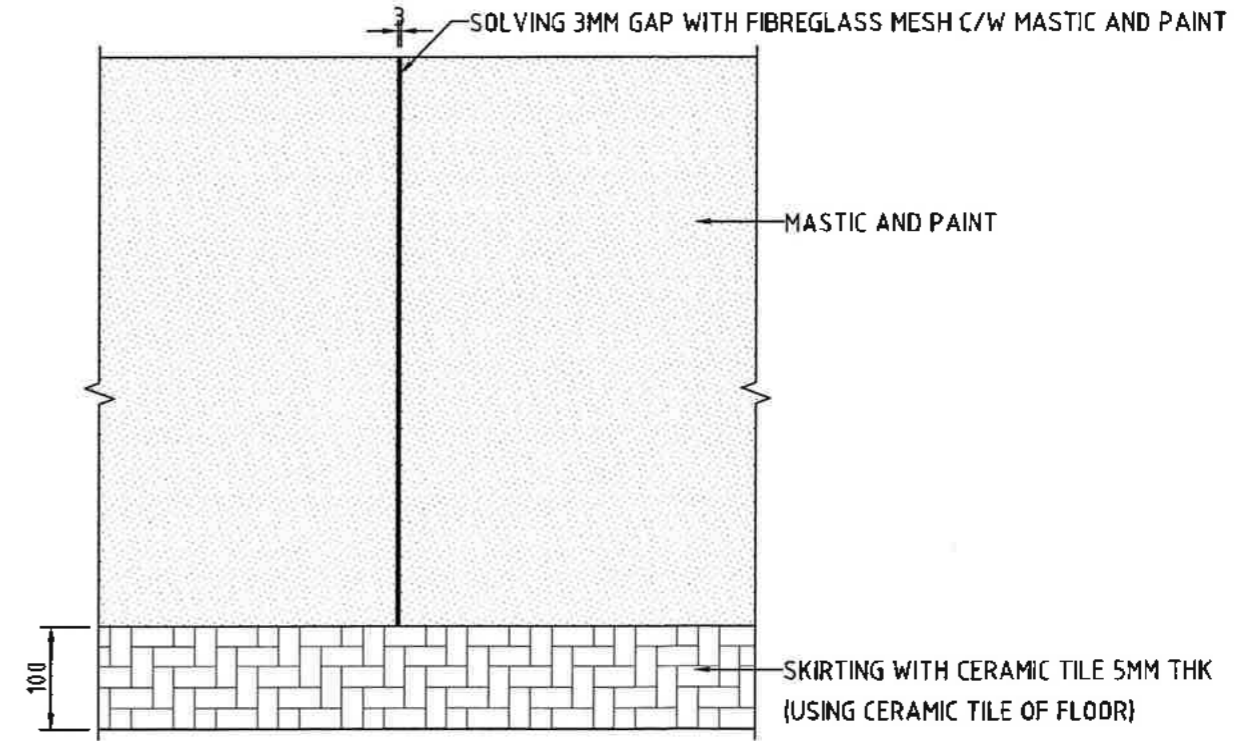
DETAIL OF WALL TYPE 1 INSIDE BATHROOM (TYPICAL)

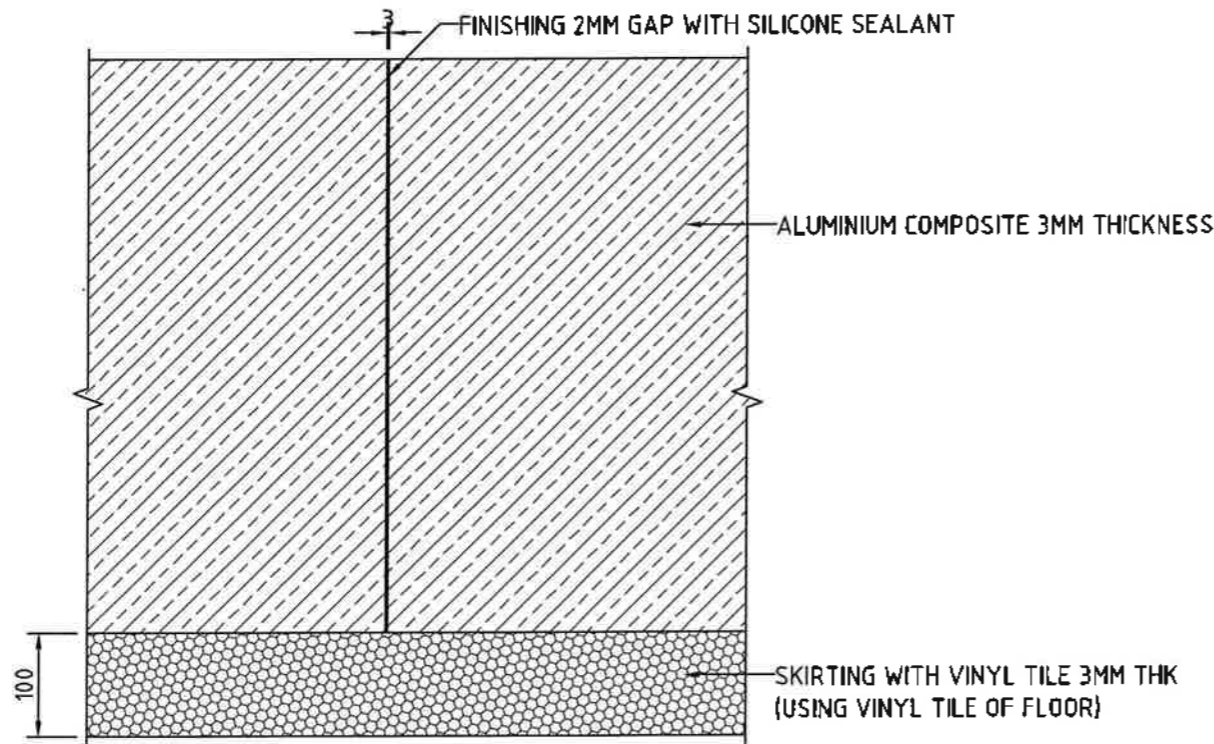
DETAIL OF WALL TYPE 2 OUTSIDE BATHROOM (TYPICAL)

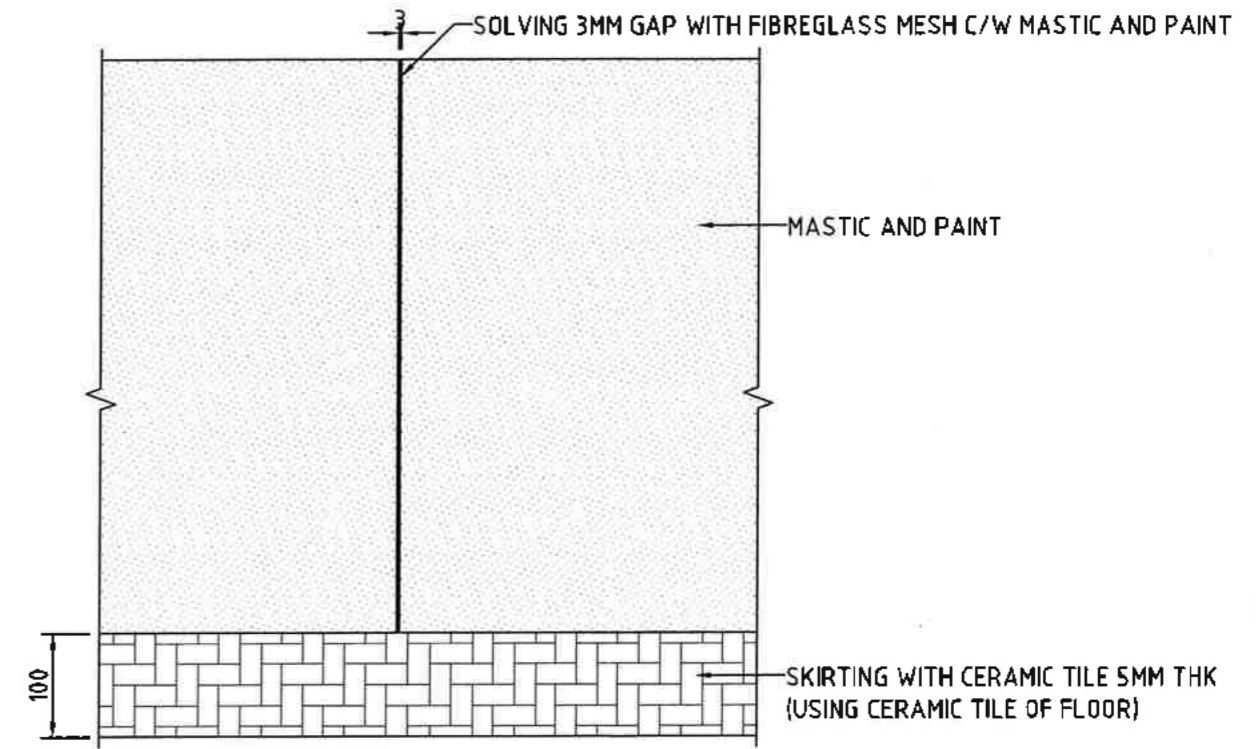
DETAIL OF WALL TYPE 2 INSIDE BATHROOM (TYPICAL)

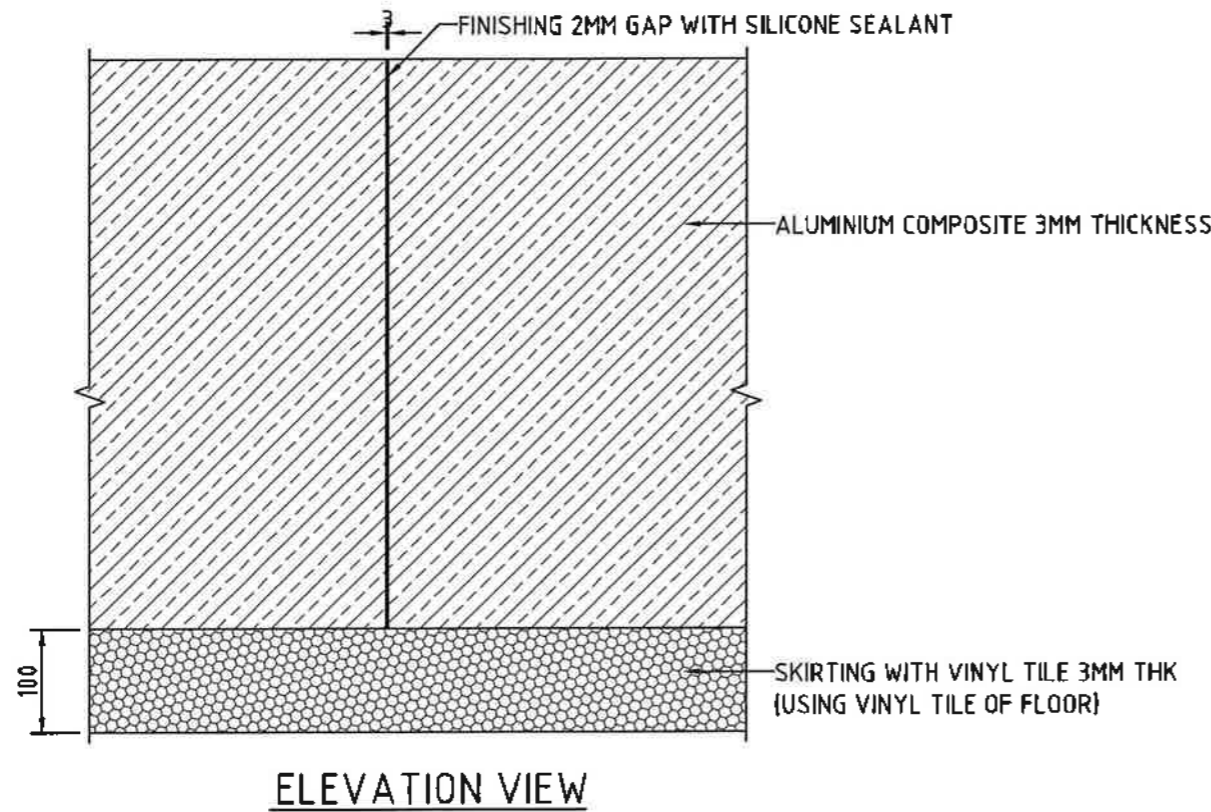
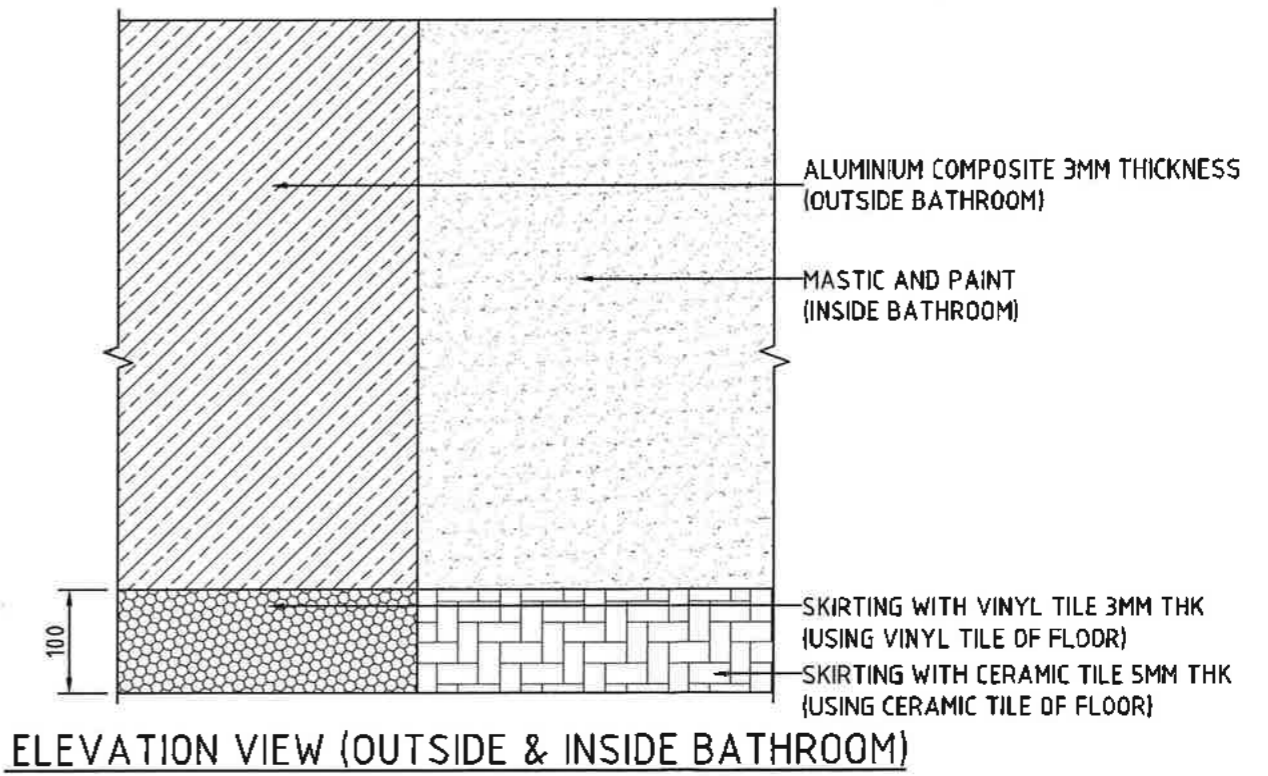
DETAIL OF WALL TYPE 3 (TYPICAL)
SCALE 1:10

DETAIL OF WALL TYPE 4 (TYPICAL)
SCALE 1:10

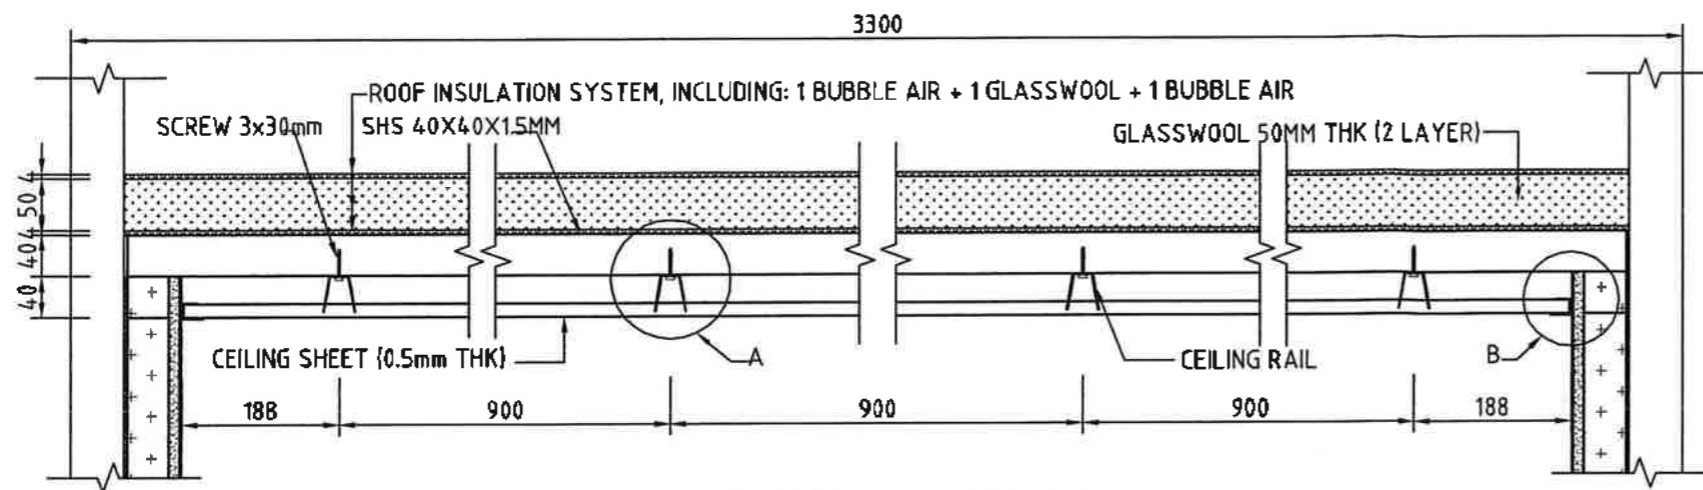
DETAIL 1 (TYPICAL)
SCALE 1:10

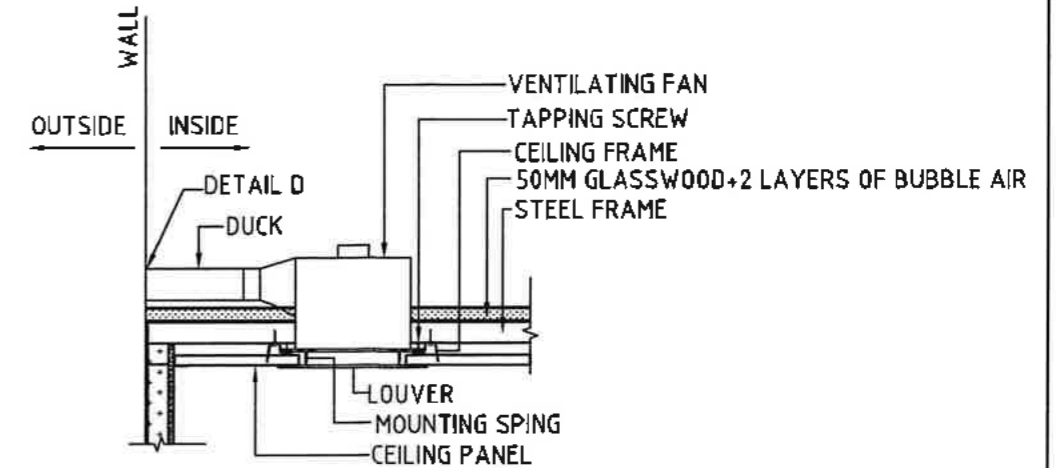
CEILING EXHAUSTED FAN INSIDE BATHROOM
SCALE 1:20

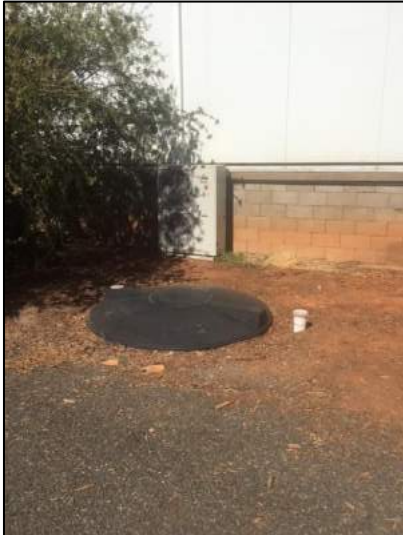
Treatment tank for recreational room

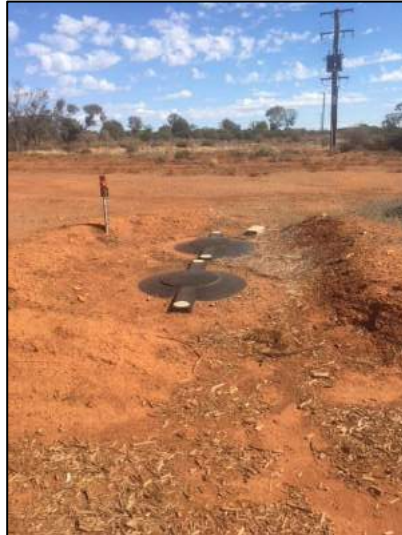
Treatment tank for laundry

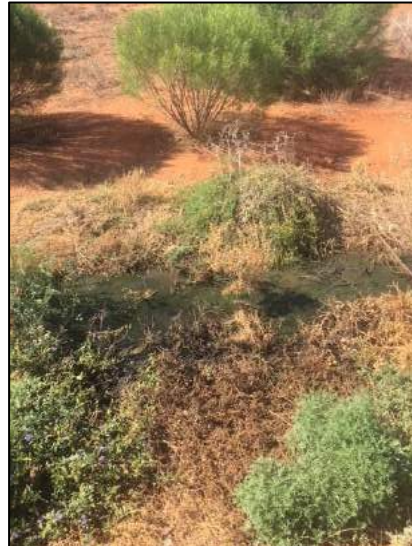
Pooling of effluent in application area for accom units

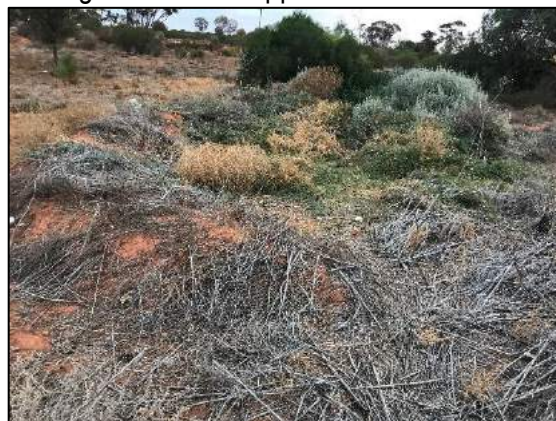
Reported location of trench for kitchen and recreation room. Vegetation maintenance required

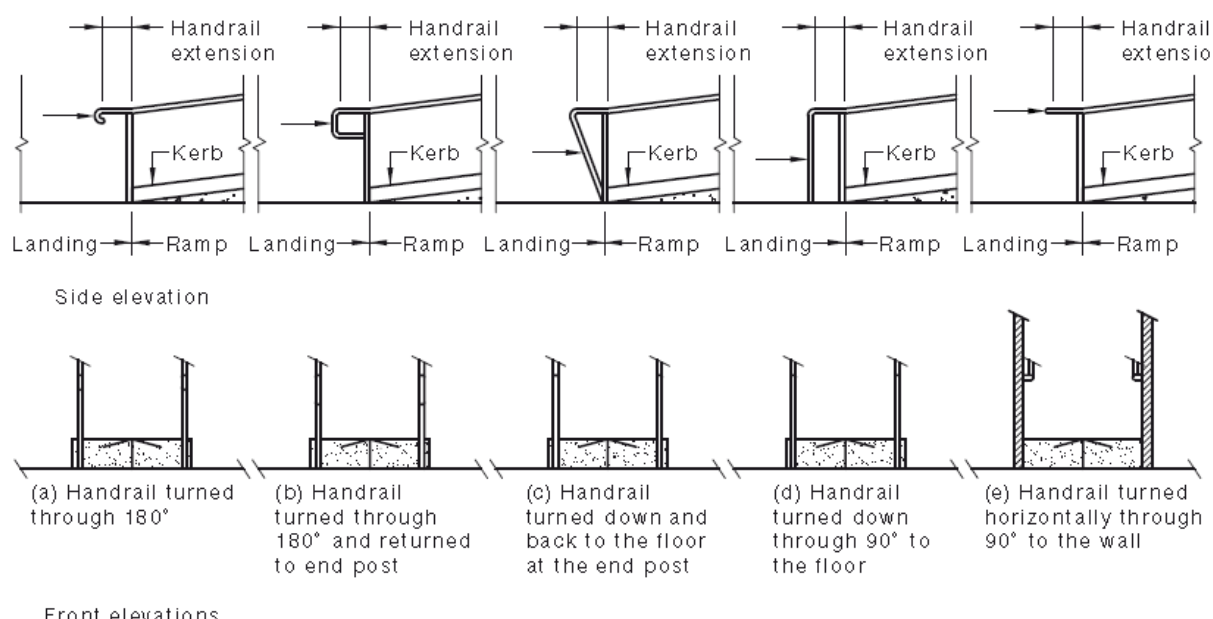
Clause	Comment	Status
	<p>1. The handrails do not provide for compliant horizontal extensions at the top and bottom of the ramp handrails as detailed in the diagram below;</p>

<p style="text-align: center;">FIGURE 15(A) RAMP HANDRAILS—EXAMPLES OF HANDRAIL TERMINATIONS</p>

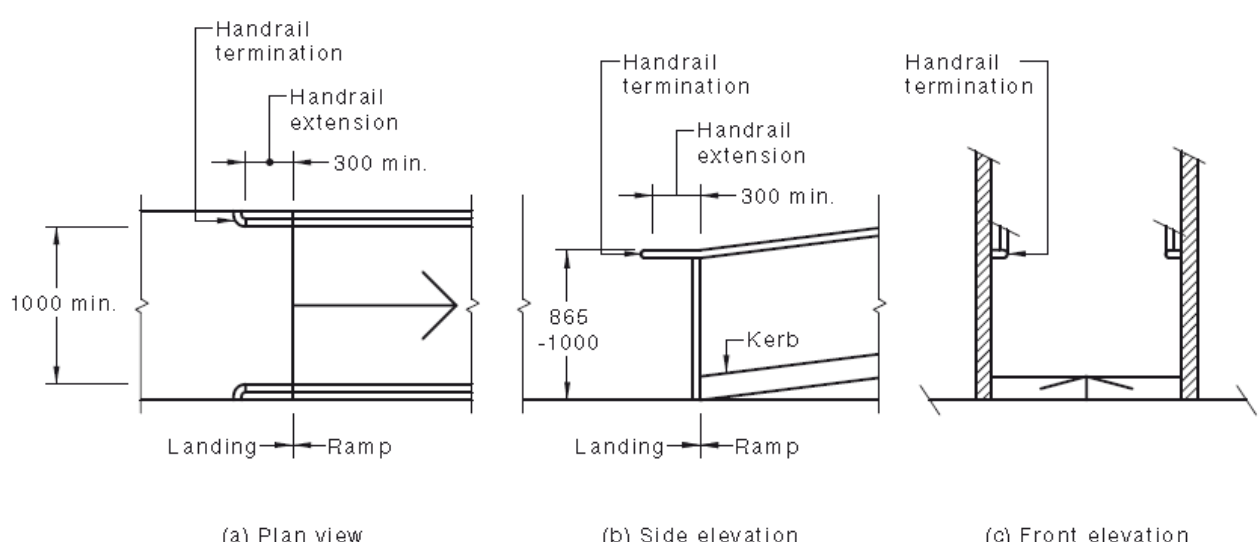
<p style="text-align: center;">DIMENSIONS IN MILLIMETRES</p> <p style="text-align: center;">FIGURE 15(B) RAMP HANDRAILS—DETAIL FOR HANDRAILS TERMINATED BY TURNING HORIZONTALLY THROUGH 90° TO THE WALL</p> <p><i>Excerpts from Figure 15(A) & 15(B) of AS1428.1-2009</i></p> <ol style="list-style-type: none"> 2. The surface of the ramp could not be verified that it would provide a slip resistance rating of P4 or R11 based on the surfacing being timber boards with mesh fixed over the top. 3. The provision of tactile indicators at the top and bottom of the ramp in accordance with AS1428.1-2009 as illustrated in the diagram below noting that the depth of tactiles required at the top and bottom of the ramp is 600mm.
